SMC-TR-94-02

AEROSPACE REPORT NO. TR-93(3904)-1

Honeycomb Sandwich Structures: Vented Versus Unvented Designs for Space Systems

October 1993

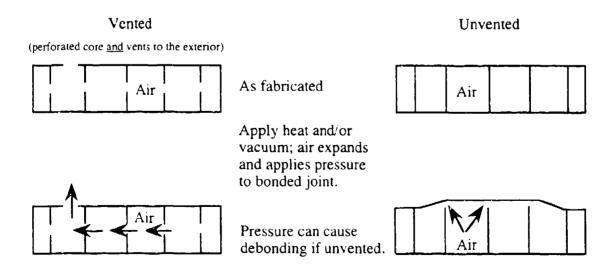
Partially vented honeycomb structures provide some venting but not sufficient to accommodate the pressure differential, so some internal pressure is developed during ascent. Larger panels are more likely to be partially vented.

Figure 1. Vented versus Unvented Honeycomb Structures
